**Office of Environment, Safety and Health Oversight  
Environment, Safety and Health**

*Type A Accident Investigation  
of the June 21, 2001*

# **Drilling Rig Operator Injury at the Fermi National Accelerator Laboratory**

August 2001

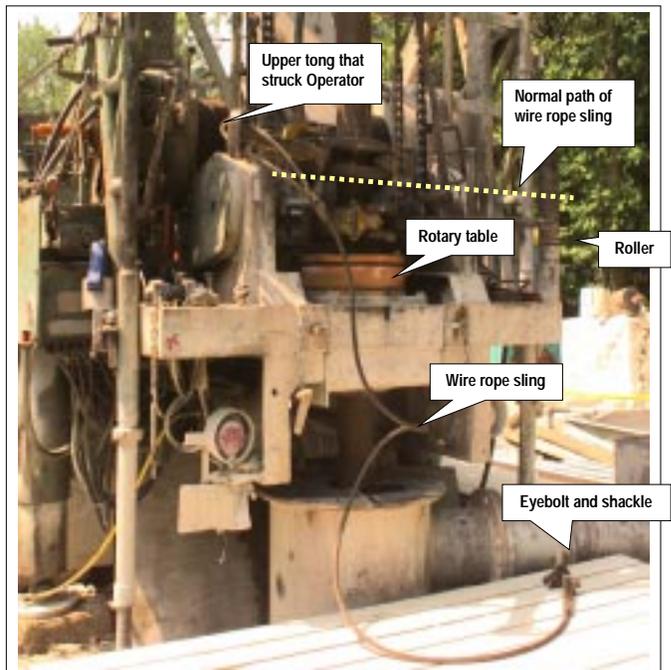
Exhibit 2-2. Drill Rig Where the Injury Occurred

The accident resulted from the failure of the weld connecting the wire rope to the hydraulic cylinder used in making and breaking threaded drill pipe section joints. Torsion is applied to the joints by mechanical tongs (in effect, pipe wrenches) that grip the outer diameter of the drill pipe section. One of the tongs is braced against a drill rig stop pin, while the other tong is operated (i.e., pulled) by a mechanical force supplied by the hydraulic cylinder. This force is transmitted through a wire rope sling connected with miscellaneous hardware.

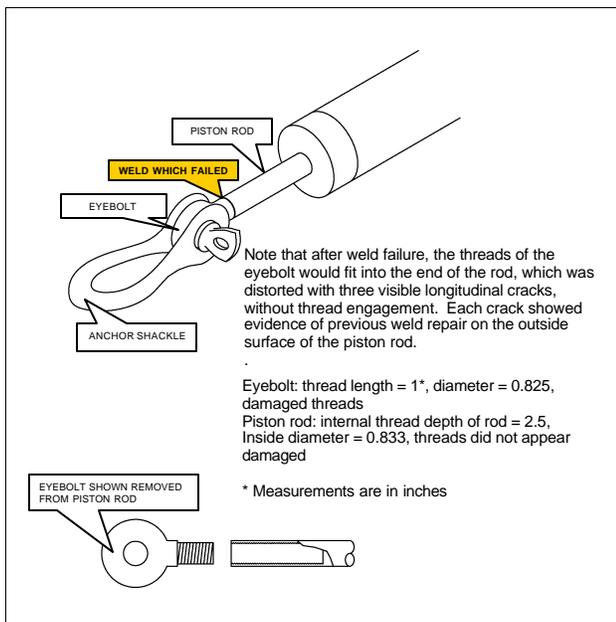
Figure 2-1. Piston Rod End Fixture

The Board determined that at least two equipment modifications were made after the drill rig was built that are relevant to the accident. In the early 1970s, the hydraulic breaking mechanism was installed to replace a manual breakout wrench used to loosen and tighten the drill pipe section joints. In 1999, the eyebolt-piston rod connection involved in the accident failed. An entry in a Layne-Western Daily Drilling report dated March 2, 1999, stated “Broke eyebolt on end of hyd[raulic] ram for breaking but we [were] able to weld it up.” The Daily Drilling report indicated that the drilling crew performed this repair in the field.

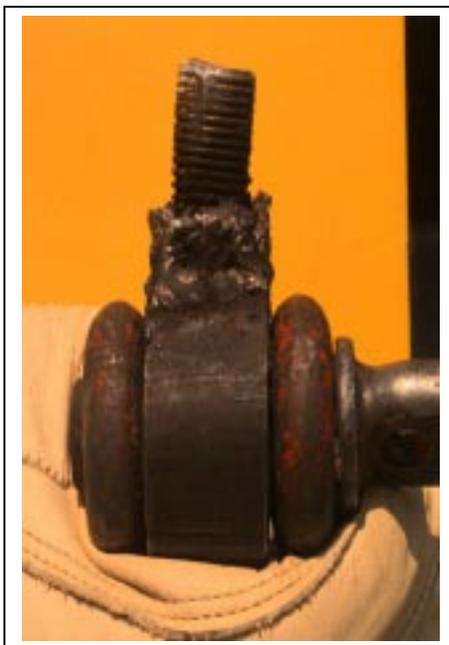
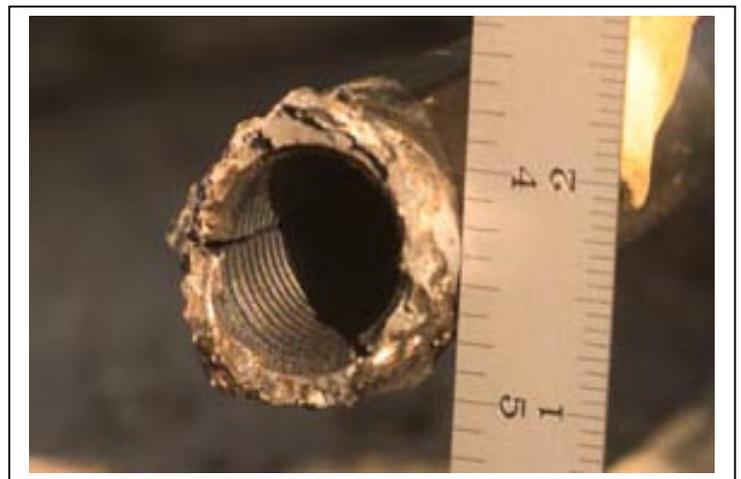
Exhibit 2-3. Eyebolt That Was Connected to the Piston Rod (Left) and the End of the Piston Rod After the Accident (Right)

The accident occurred when the welded connection between the eyebolt and the hydraulic cylinder piston rod failed during operation. This event released tension on the wire rope sling connecting the eyebolt to the upper tong. The sling, with the shackle and eyebolt attached, sprang back toward the end of the drilling rig where the Operator and his Helper were standing.

The evaluation considered the condition of the eyebolt after the accident, and the condition of the end of the piston rod, as shown in Exhibit 2-3. It included detailed visual inspection, measurements, hardness testing, and engineering analyses. Visual inspection disclosed three longitudinal cracks in the threaded end of the piston rod, one of which is visible in Exhibit 2-3. The threaded portion of the eyebolt was considerably deformed, as can be seen in Exhibit 2-3.

Examination of the eyebolt and piston rod following the accident revealed that these components separated when a weld that held them together failed. The threaded portion of the eyebolt had been inserted into the threaded socket in the end of the piston rod, but there was apparently little or no thread engagement due to expansion of the socket diameter. This expansion was attributed to through-wall cracks in the socket and to possible distortion due to weld repairs of previous cracks. The load on the connection was apparently supported entirely by a circumferential weld that joined the shoulder of the eyebolt to the end of the piston rod. The weld failed either because of cracks that developed due to fatigue related to repetitive loading or because of unusually high stress at the time of failure.
